REPORT NO: NAWCADPAX/RTR-2000/97

S-3B SMALL-SCALE APPLIQUÉ COUPON FLIGHT TEST EVALUATION RESULTS

9 January 2001

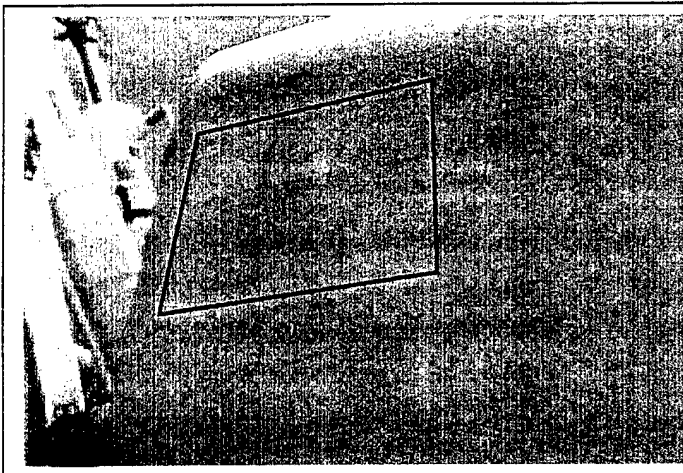
18. Six coupons in a 2 x 3 pattern were applied at site 2, with the FP500 material on the left row and the FP1500 material on the right row (looking forward). Unperforated coupons were applied to the site on the left lower door, and perforated coupons were applied to the site on the right lower door. Figure 3 shows the coupons at site 2 on the left lower door prior to flight, and figure 4 shows the coupons at site 2 on the right lower door prior to flight. Following the initial test flight, both the FP500 and FP1500 coupons remained attached to the surface of the aircraft, and did not show any signs of deformation or failure. The coupons appeared as they did prior to the flight; therefore, no photographs were taken of the coupons at site 2 following the flight.

Figure 3: Coupons at site 2 on the left lower gear door prior to flight. (Test site outlined in black.)

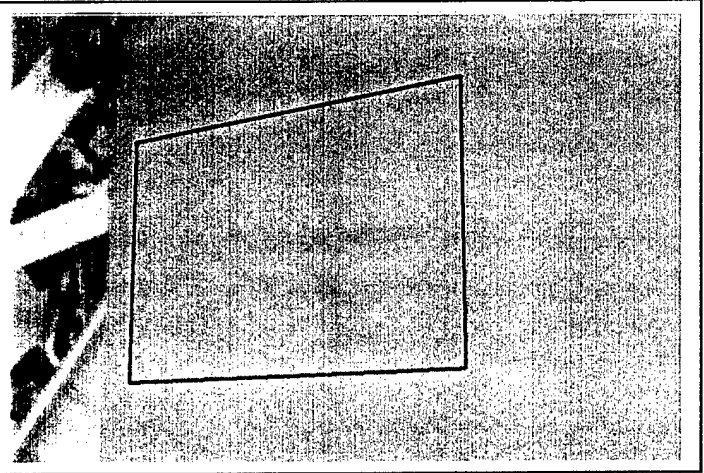
Figure 4: Coupons at site 2 on the right lower gear door prior to flight. (Test site outlined in black.)

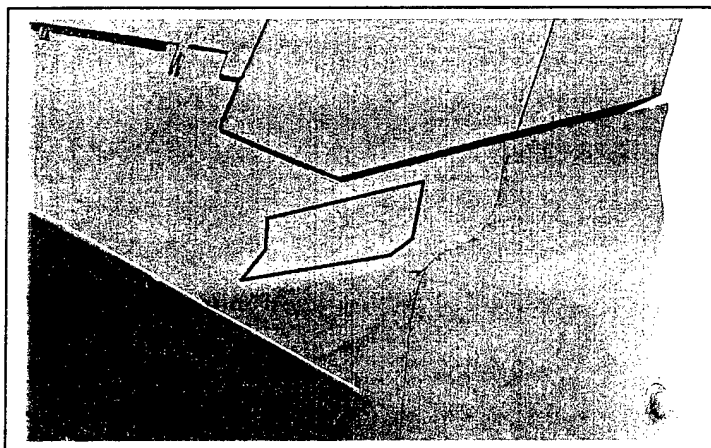
19. Eight coupons in a 2 x 4 pattern were applied at site 3, alternating between the FP500 and FP1500 material in a checkerboard pattern. Only unperforated coupons were applied. Figure 5 shows the coupons at site 3 prior to flight. Following the initial test flight, both the FP500 and FP1500 coupons remained attached to the surface of the aircraft, and did not show any signs of deformation or failure. The coupons appeared as they did prior to the flight; therefore, no photographs were taken of the coupons at site 3 following the flight.

Figure 5: Coupons at site 3 on the vertical tail below the rudder prior to flight. (Test site outlined in black.)

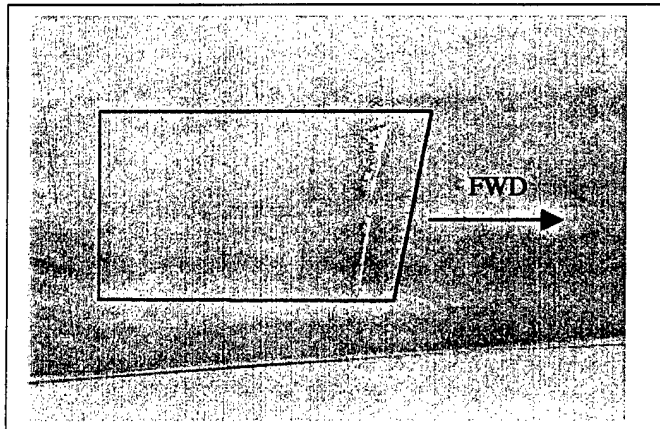
Following the failure mode test flight, the prepeeled coupons at site 1 were inspected. Figure 8 shows the prepeeled coupons at site 1 on the left wing following the flight, and figure 9 shows the prepeeled coupons at site 1 on the right wing following the flight. Neither the FP500 nor FP1500 material experienced any additional peeling, and the film tattered as desired.

Figure 8: Prepeeled coupons at site 1 on left wing following flight. (Test site outlined in black.)

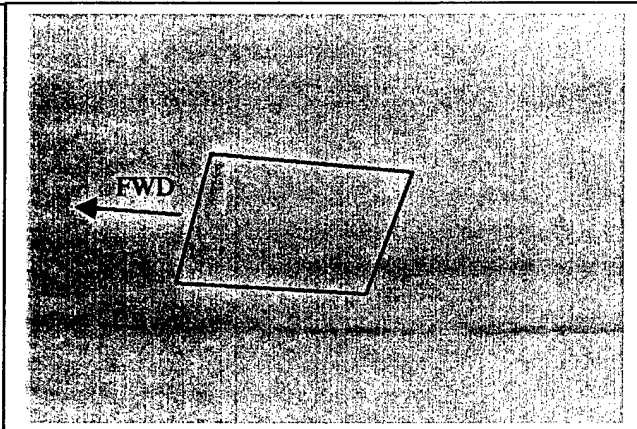
Figure 9: Prepeeled coupons at site 1 on right wing following flight. (Test site outlined in black.)

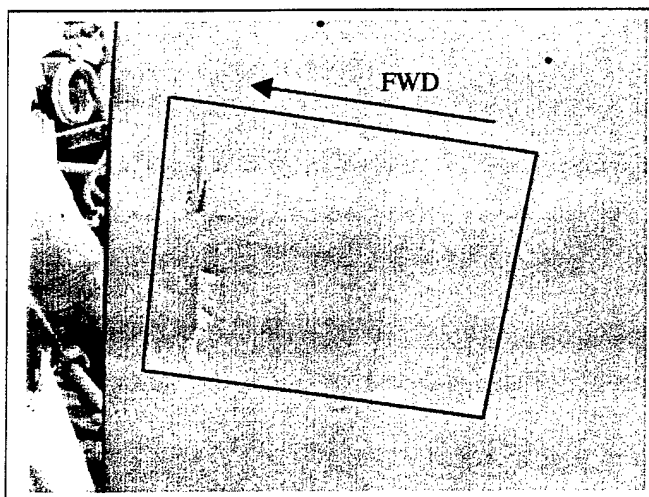
22. The leading edge of the two forward-most coupons was peeled back at site 2 on the left and right lower gear doors. Figure 10 shows the prepeeled coupons at site 2 on the left door prior to flight, and figure 11 shows the prepeeled coupons at site 2 on the right door prior to flight.

Figure 10: Prepeeled coupons at site 2 on the left lower gear door prior to the flight. (Test site outlined in black)

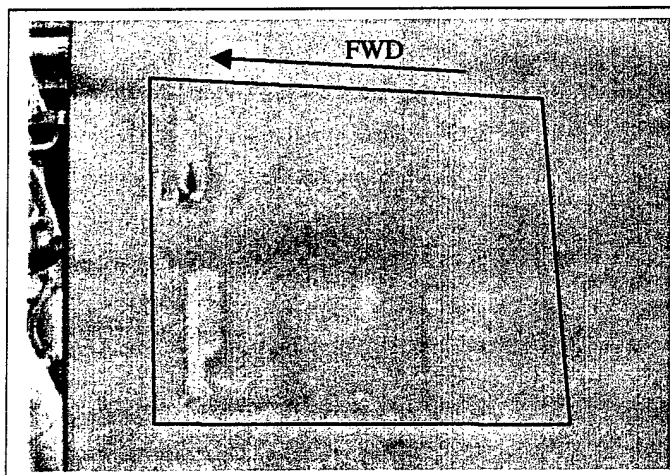
Following the failure mode test flight, the prepeeled coupons at site 2 were inspected. Figure 12 shows the prepeeled coupons at site 2 on the left lower gear door following the flight, and figure 13 shows the prepeeled coupons at site 2 on the right lower gear door following the flight. Neither the FP500 nor FP1500 material experienced any additional peeling, and the film tattered as desired.

Figure 12: Prepeeled coupons at site 2 on the left lower gear door following the flight. (Test site outlined in black.)

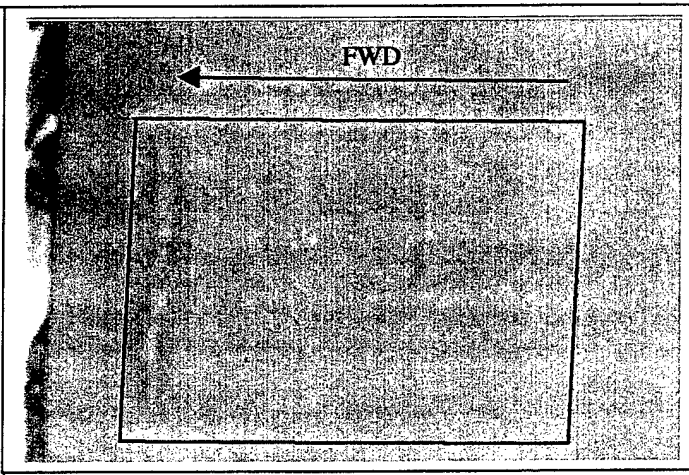
Figure 13: Prepeeled coupons at site 2 on the right lower gear door following the flight. (Test site outlined in black.)

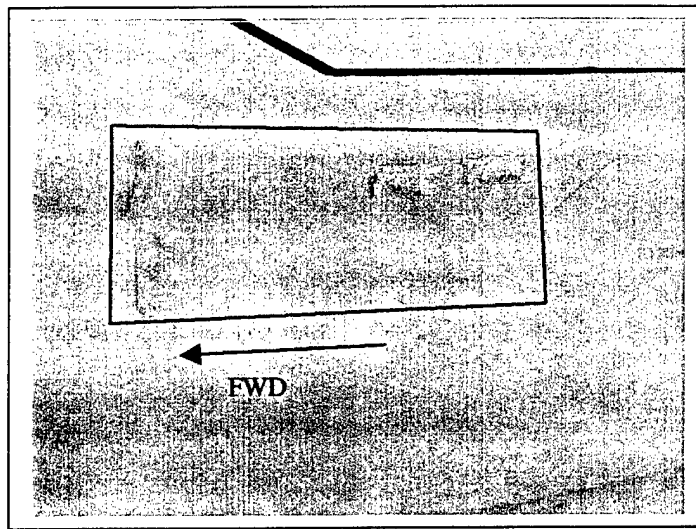
23. The leading edge of the two forward-most coupons, and the upper edge of the upper-most aft coupons were peeled back below the rudder. Figure 14 shows the prepeeled coupons at site 3 below the rudder prior to flight.

Figure 14: Prepeeled coupons at site 3 on the vertical tail below the rudder prior to flight.
